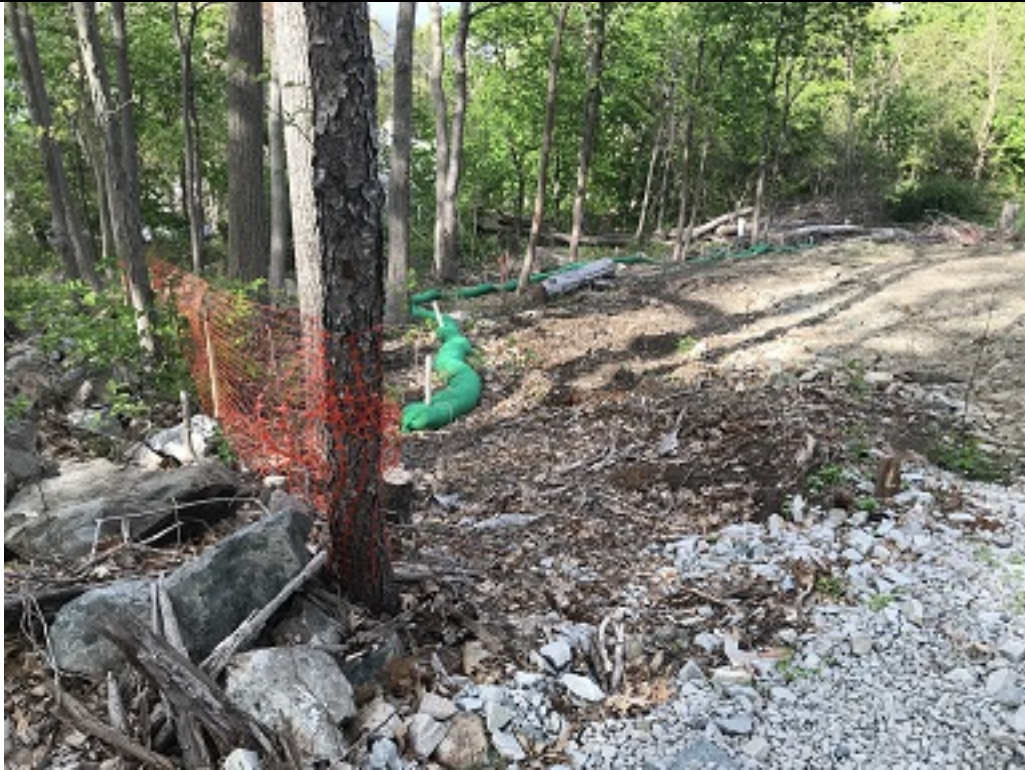
Entrance at Kilby Street construction fence is off site, property line stakes in upper center of photo.
5-12-21

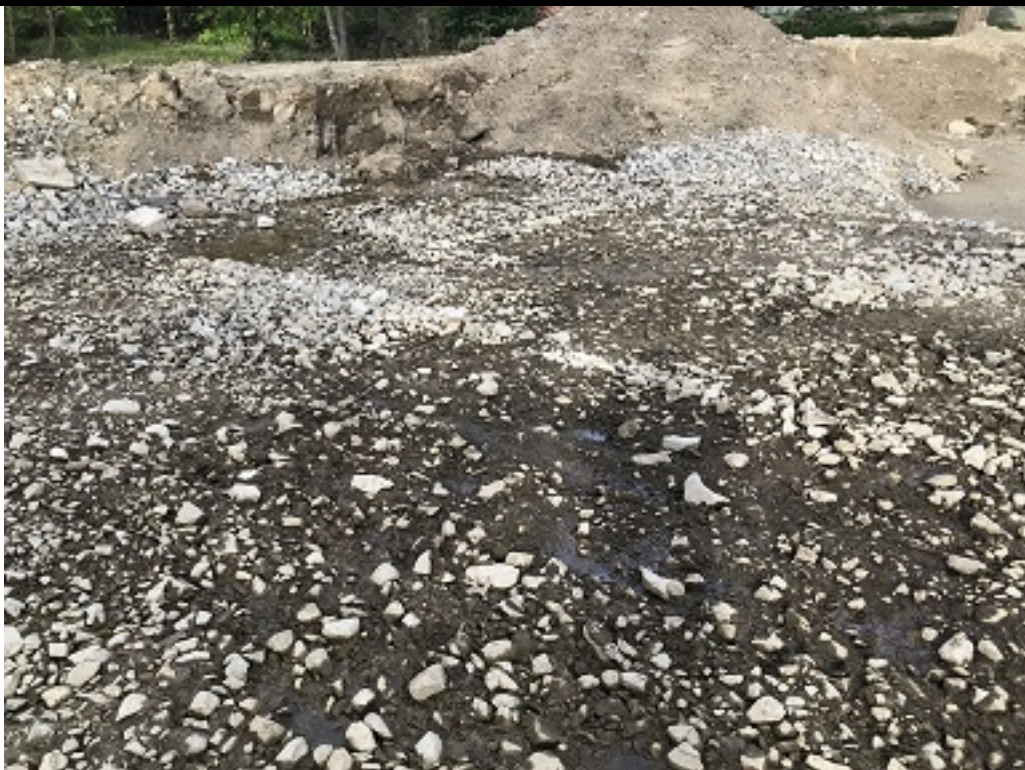
Approximate location of house pad at the time of my site visit water was visible in areas on the surface.
5-12-21

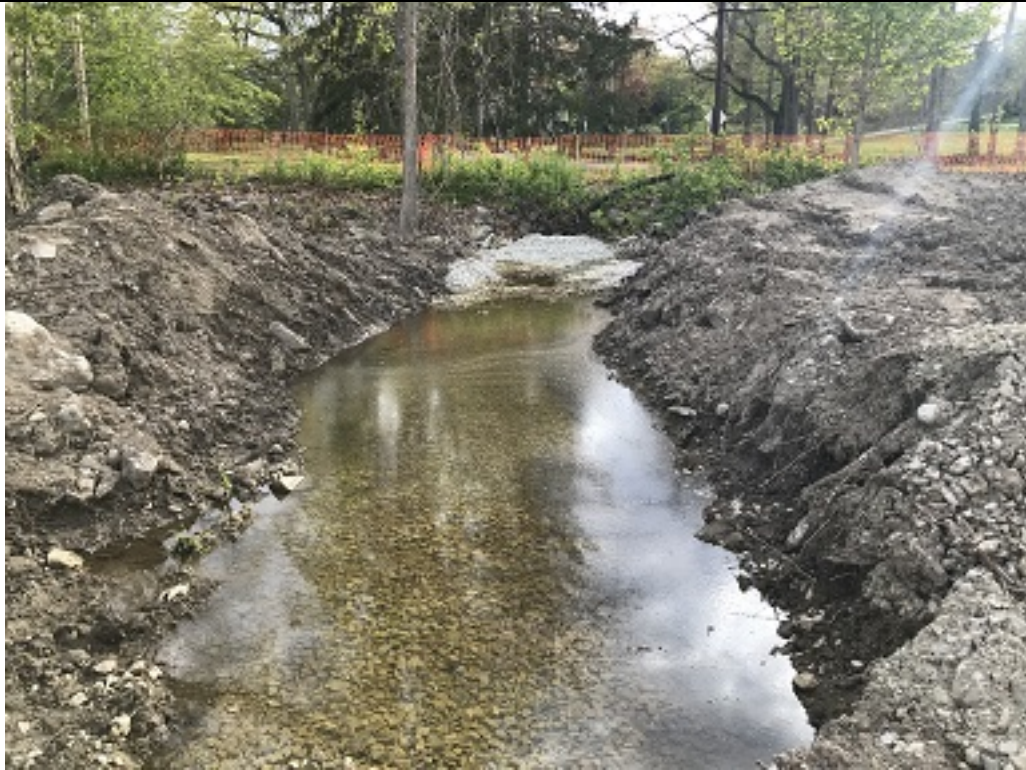
Stone channel on the site with pipe visible at the far end. Looking at Summer Street beyond construction fence.

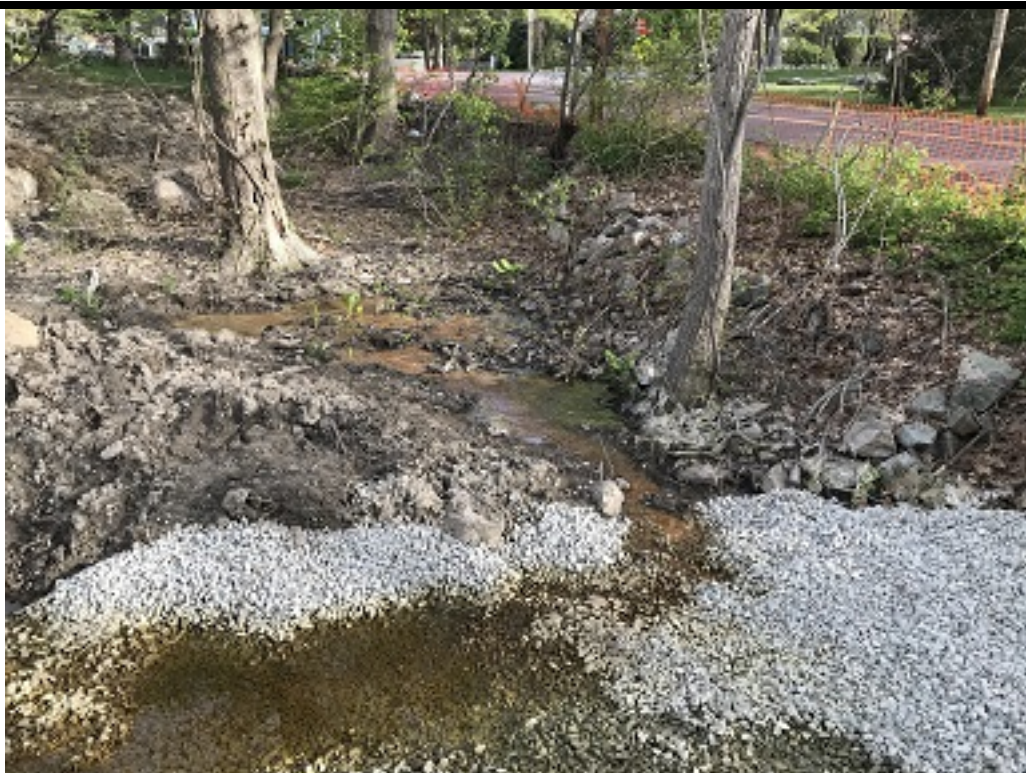
Another view at the edge of Summer Street top left.

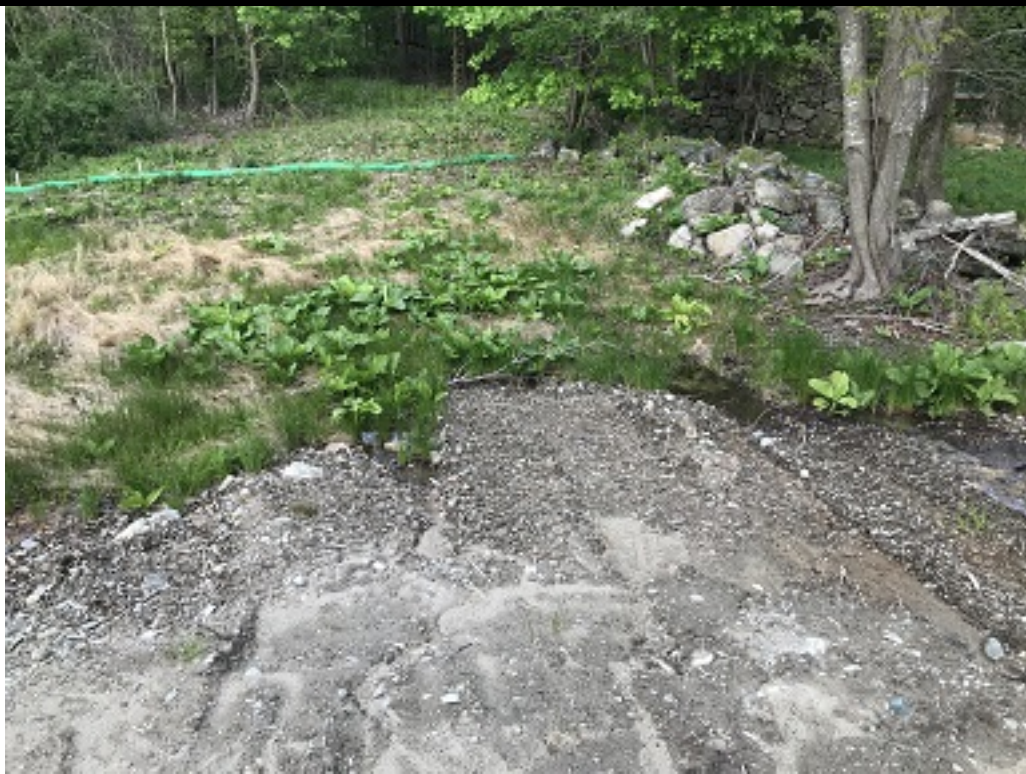
Location of the lower end of the infiltration basin. Note water and skunk cabbage indicating poor soils and high water table.
5-12-21

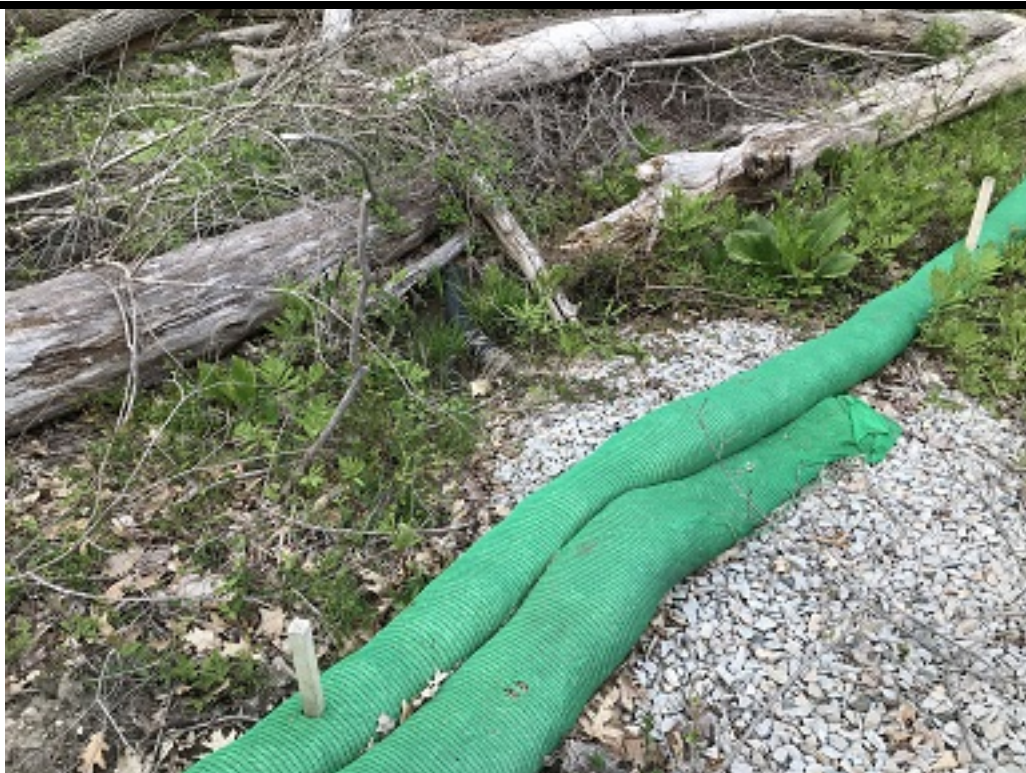
End of stone trench and 4 inch pipe past sediment barrier.
5-12-21
