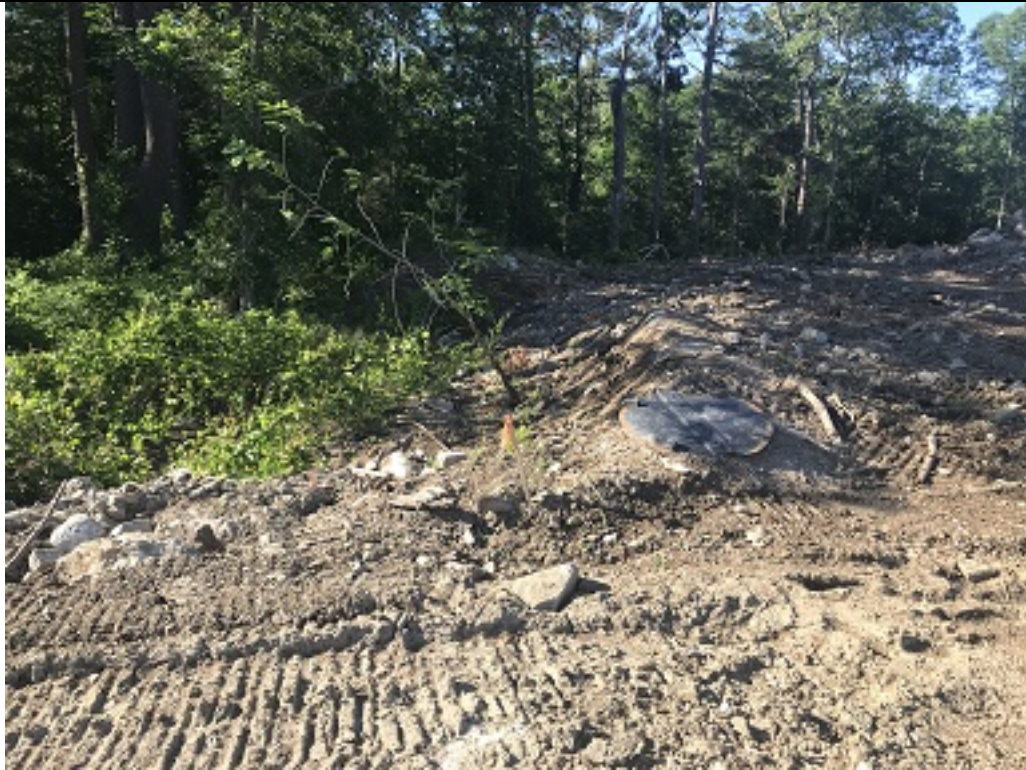
6-17-21

Looking South at a piece of exposed ledge behind the metal plate, it is unclear where the Tree Preservation Area is relative to this ledge but it would be to the right of the ledge in the photo based on prior estimations from available fencing. The stake is not identified.

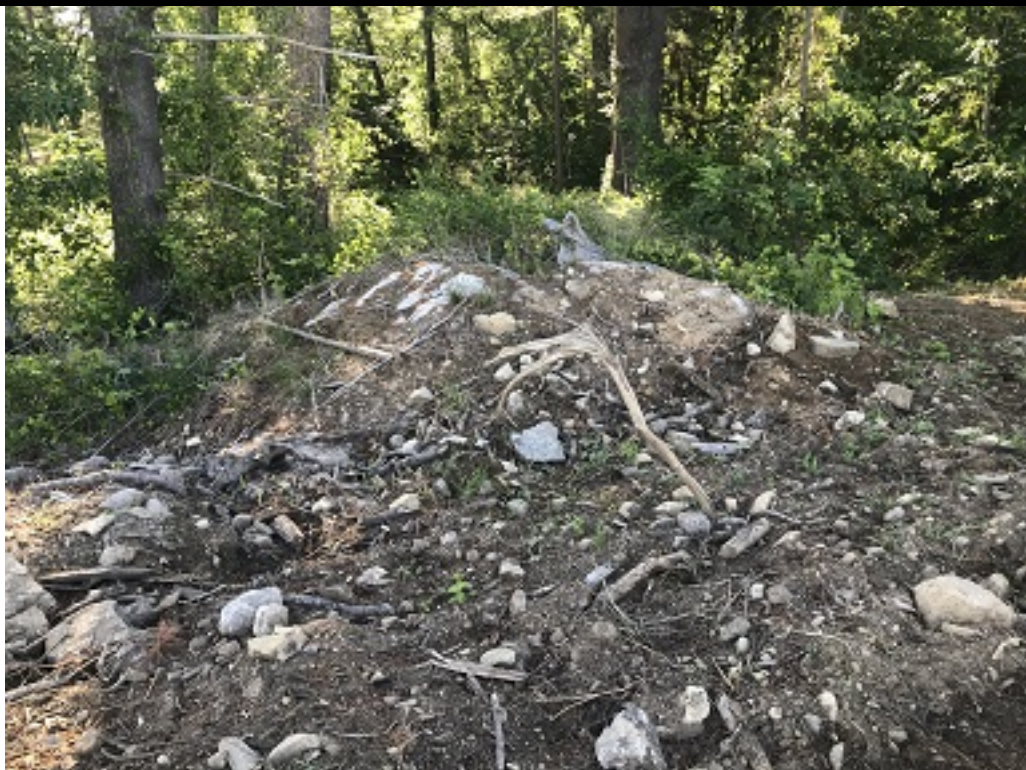
6-17-21

Looking east from the disturbed part of the lot at another piece of exposed ledge, it is unclear where the Tree Preservation Area is relative to this ledge. This is south of the prior picture and the mulch log is behind this outcrop of ledge

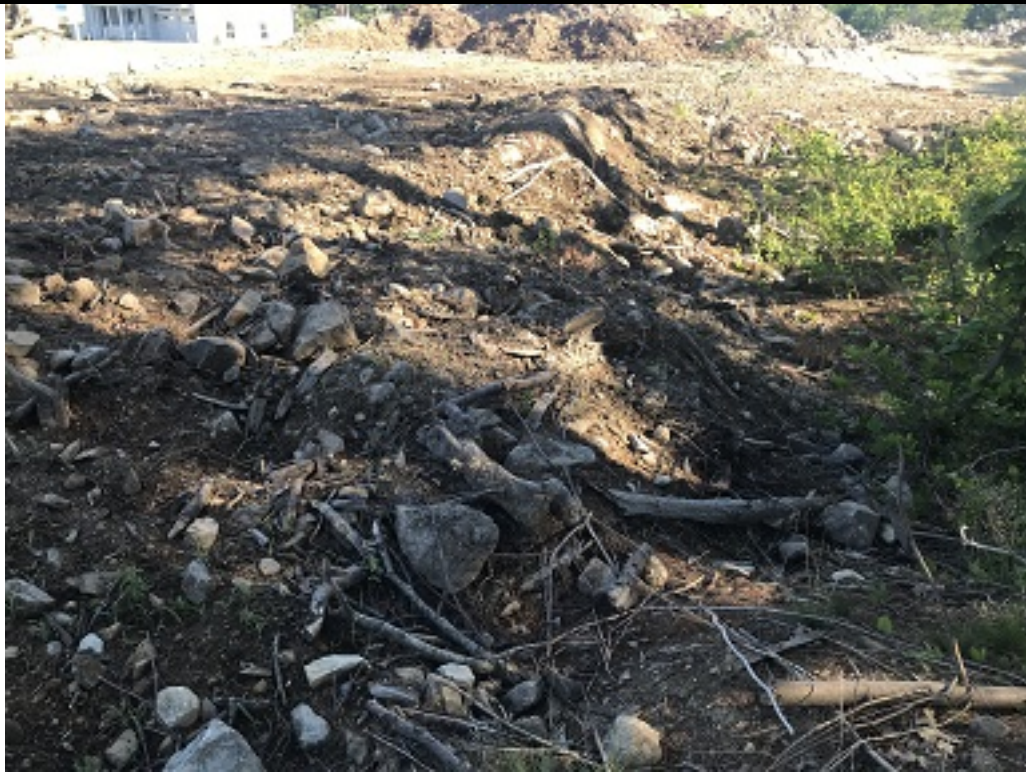
Looking North, the exposed ledge at the top of the picture is the same as in the first picture. As can be seen this is mostly fill. The ledge in the second photo taken is behind where I am standing.
6-17-21

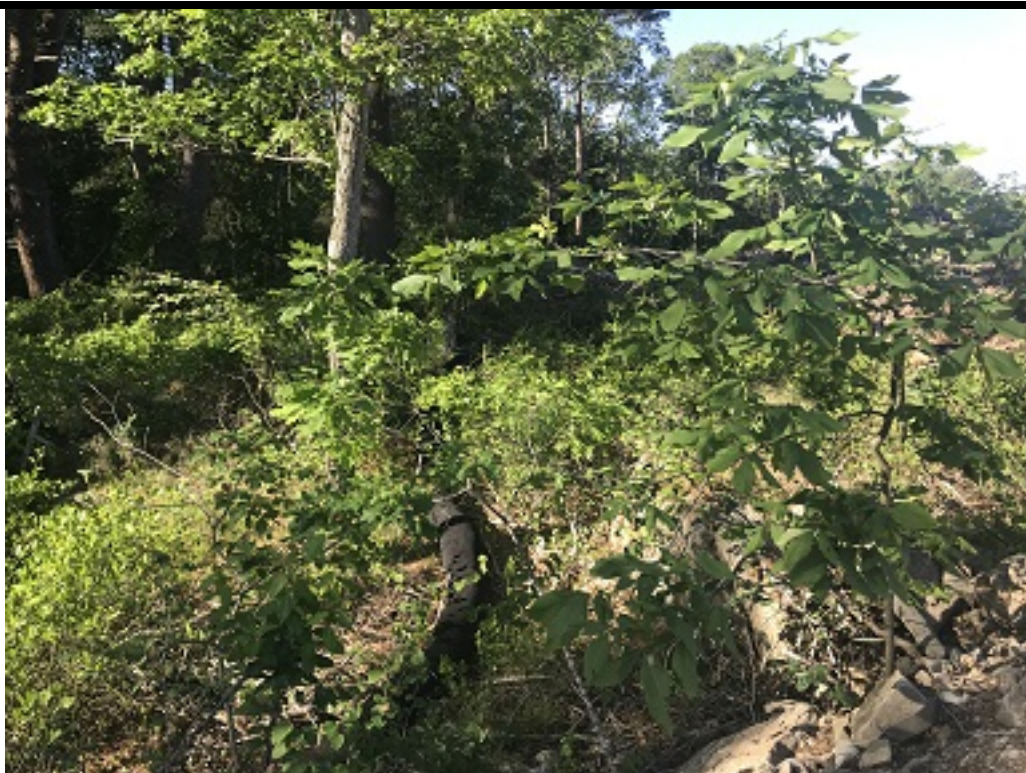
This is a section of the older mulch log. As noted it is unclear where this is located relative to the Tree Preservation Area as it is not indicated on the plans revised 6-7-21.
6-17-21
