SPECIAL TOWN MEETING QUESTION OF THE WEEK

**Week 2:
What are the Deficiencies of the
Current Police & Fire Stations?**

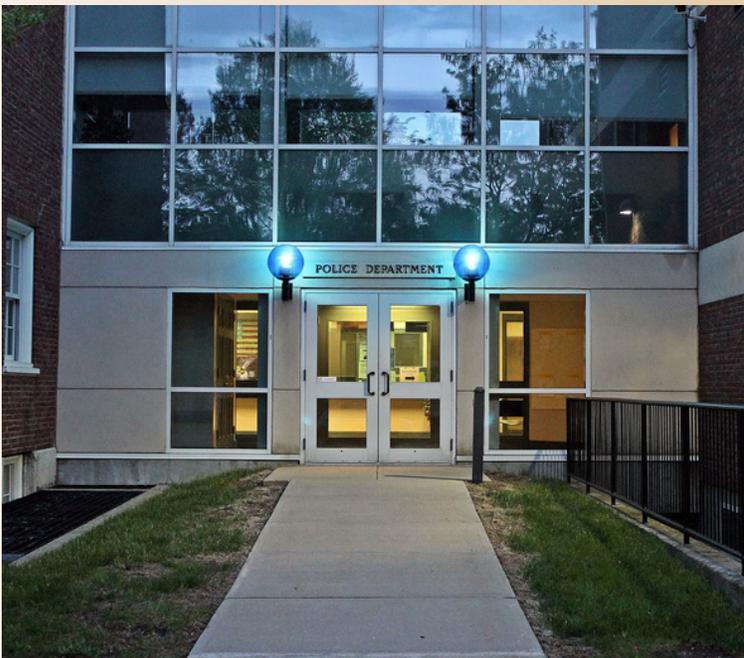
Current Hingham Police Station

Remodeled from a middle school in 1998 and located at 212 Central Street, this facility is too small and outdated to accommodate modern police services, equipment, and staff.

Inadequate entry area: The Police Station lobby, as a public space, serves many functions. Inside the Headquarters, released suspects exit from the same single door/lobby that victims, family members, and witnesses use to enter. The resulting close proximity creates safety risks for officers and civilians and provides no privacy to members of the public wishing to discuss sensitive issues with officers.

Lack of sufficient meeting rooms: All Police Headquarters rooms and offices serve several functions. There is no dedicated space for officers to interview suspects, victims, or family members. As such, it is difficult to conduct office operations and find private space for confidential interviews with detectives, officers, mental health professionals, or the domestic violence advocate.

No training spaces: A single, small room serves inadequately as a training space, roll call room, break room space, community event space, and private interview space. Officers must conduct hands-on training offsite in other agencies' facilities as Hingham's Police Station lacks appropriate space. There is no dedicated space supporting officers' undistracted learning and professional development.

Inadequate storage: Most rooms perform several functions, leaving little space to store gear, uniforms, and supplies. These items are crowded into hallways, stairwells, cells, and service bays throughout the station. When the 911 dispatch center moved into Town Hall in 2012, the Station lost 1,500 s.f. of space, further exacerbating storage and space needs

Inadequate traffic circulation: Externally, a single driveway provides access to the building's rear, which hosts cramped police vehicle parking and prisoner transfer. There is no alternate path for ingress and egress, creating operational and safety risks.

Antiquated facility restricts achievement of formal accreditation: Formal accreditation is a process that police departments use to meet modern standards in policing and are followed to ensure public confidence. The current facility does not meet accreditation standards for transportation and holding facilities, evidence control, records storage, victim/witness assistance and training facilities.

Additionally: Inability to accommodate the needs of male & female officers; Locker room space and lockers are inadequate to meet professional and personal needs; The rooms offer inadequate storage space for officer uniforms and gear; Available lockers are too small, allowing no space allowing for drying officer gear, charging officer electronics and lights, or securing duty bags; As the number of female officers in Hingham has grown, our current female locker room space has become insufficient.

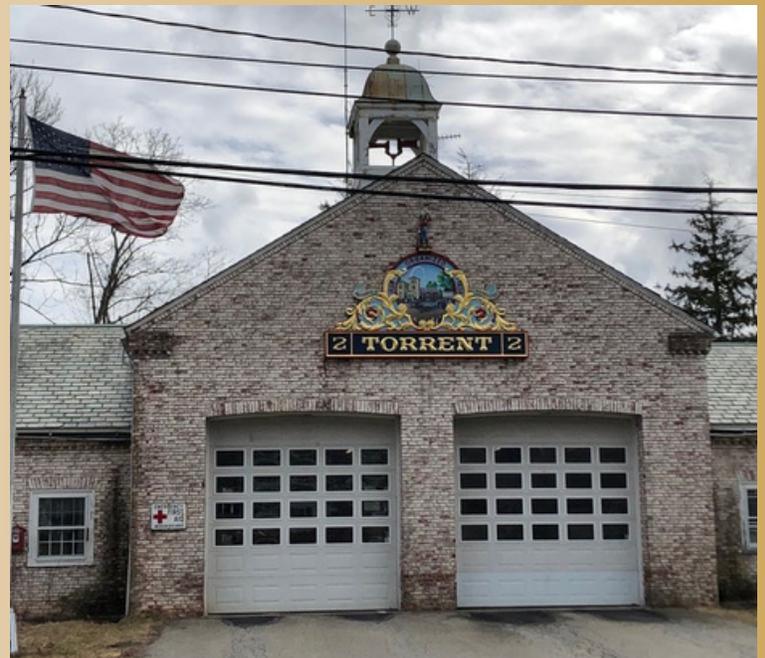
Current Hingham North Fire Station

Built in 1941 and located at 230 North Street, this facility is no longer suitable for modern fire and emergency medical services, as it lacks the amenities and space firefighters rely on every day.

Safety concerns: Today's firefighters face a number of safety risks that were not contemplated in 1941 era design standards. These include exposure to cancer causing chemicals, increased risk of cardiac problems, trip hazards and proper aisle space between modern fire engines.

Equipment deficiencies: The facility's boiler, installed in 1942, is inefficient. The station's electrical system dates to the 1940s. The station has a turnout gear washer located in the boiler room, but no dryer, forcing gear to hang dry over the buildings mechanical equipment.

Lack of space & storage: Small bays prevent indoor storage of two fire trucks and two ambulances, the ideal apparatus setup for fire response from this station. Limited driveway space prevents outdoor maintenance without disrupting the street and sidewalk. Space for storing emergency medical supplies is extremely limited. Exercise equipment is crowded into a former janitorial utility space.

Additionally: No separate facilities for male & female firefighters; Lack of separate sleeping quarters and inadequate bathroom facilities denies privacy to all firefighters living in this facility during their 24-hour shifts; Location not optimized to support Hingham's current needs; Given the district overlap the current location shares with Central Station, operations in North Hingham are not optimized especially given the recent growth along 3A corridor.
