RE: DEP File No. 034-1329 – Salt Marsh Monitoring Report  
5 Bare Cove Lane, Hingham, Massachusetts

**PHOTOGRAPHIC  
DOCUMENTATION**  
Salt Marsh Restoration  
5 Bare Cove Lane  
Hingham, Massachusetts

SITEC PROJ. NO.  
SE18-1374

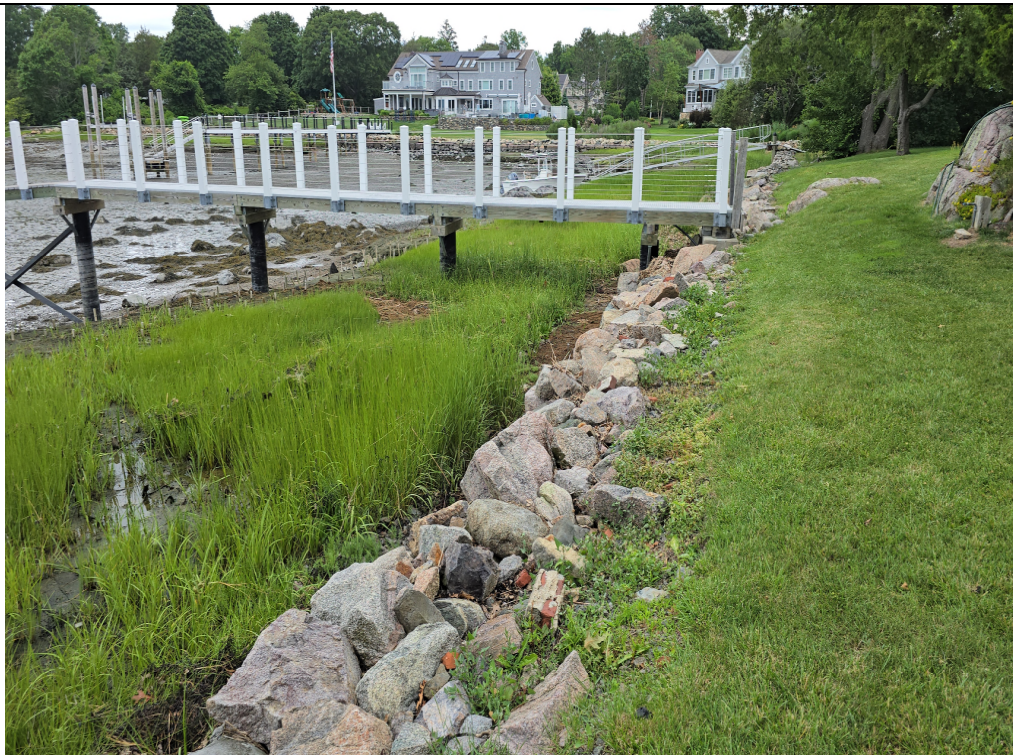
C-1

Main area of salt marsh restoration area on south side of dock. Plantings are thriving.

- *Spartina alterniflora* – South Side of Dock: The majority of plantings on the south side of the dock are in good condition with observed new growth, with the exception of the plantings that were clearly planted too low in the intertidal zone.

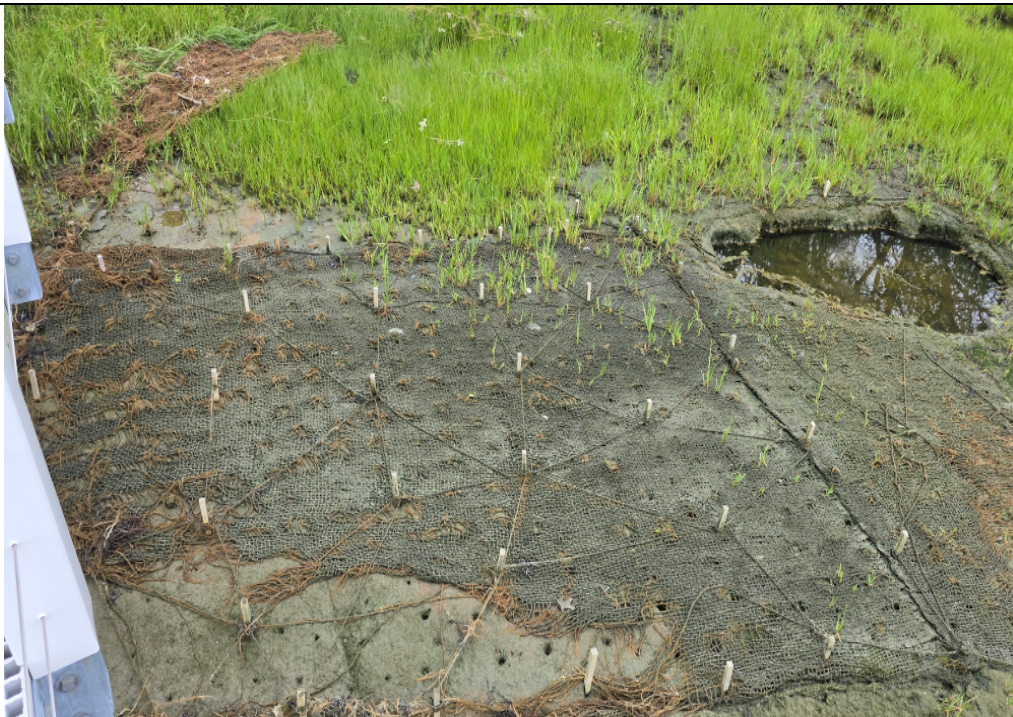
C-2

Seaward edge of southern side of salt marsh restoration area. Plantings toward seaward edge too low to thrive.

- Seaward Plantings: Many plantings along the seaward edge of the restoration area on the north and south sides of the dock were installed too low in elevation to survive the tidal cycle. These areas experience prolonged inundation, resulting in plant die-off. The current seaward limit of healthy vegetation appears consistent with that of adjacent undisturbed areas. SITEC estimates the die-off affects less than 25% of the total restoration area.

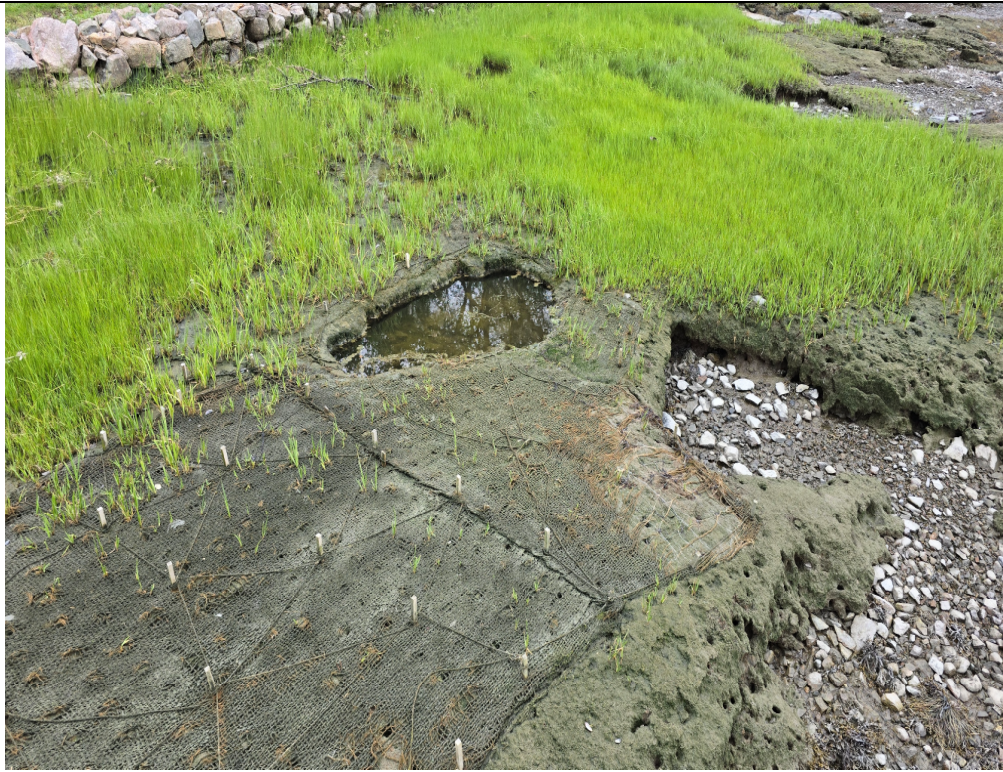
C-3

Salt marsh restoration area on southerly side of dock.

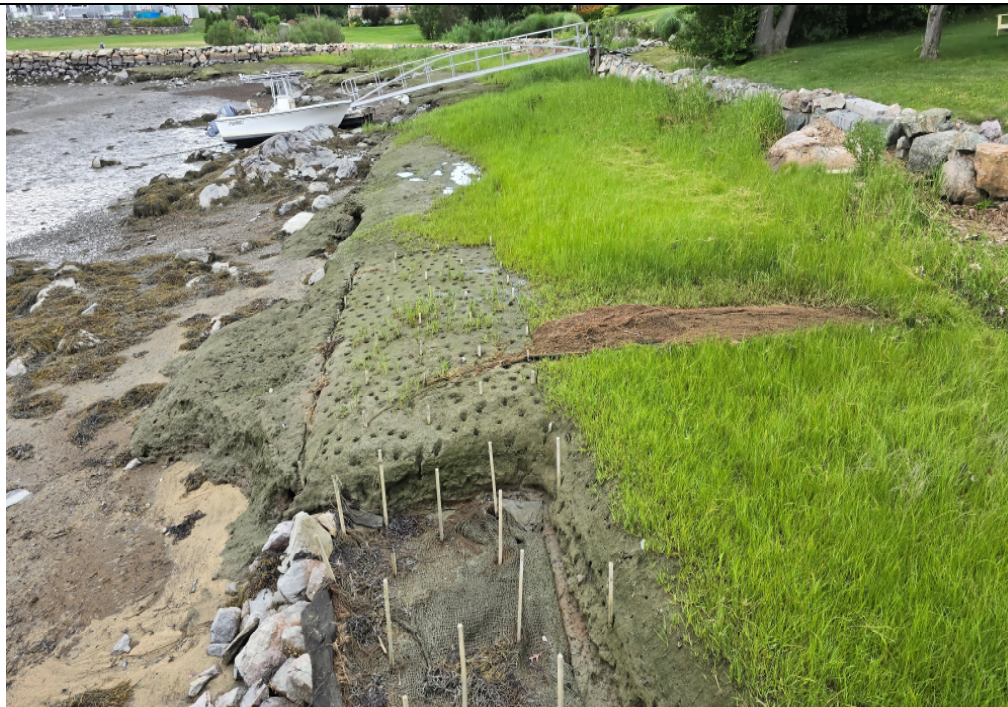
C-4

- Float-Damaged Area: The previously restored float-damaged area has experienced settlement and washout. The installed rock sill remains intact and stable. SITEC and the owner seek guidance from Conservation staff on how to handle this issue.

Salt marsh restoration area on northerly side of dock. Float damage fill has washed out.

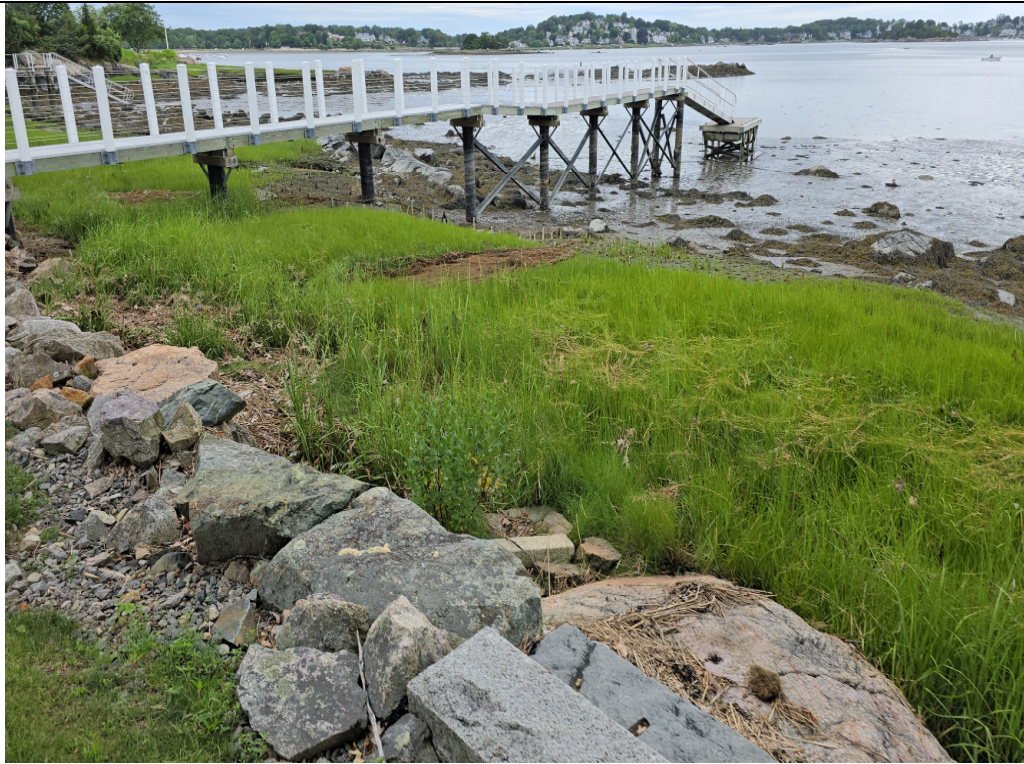
C-5

Salt marsh restoration areas to the north of dock and beneath dock.

- Landward Dock Plantings: Plantings beneath the landward end of the dock are not thriving, with little to no new growth observed. Also, there were leaves covering the substrate. It is recommended that this area be raked out by hand. It is likely that this area will require additional plantings. New plantings should be species more tolerant of drier conditions.

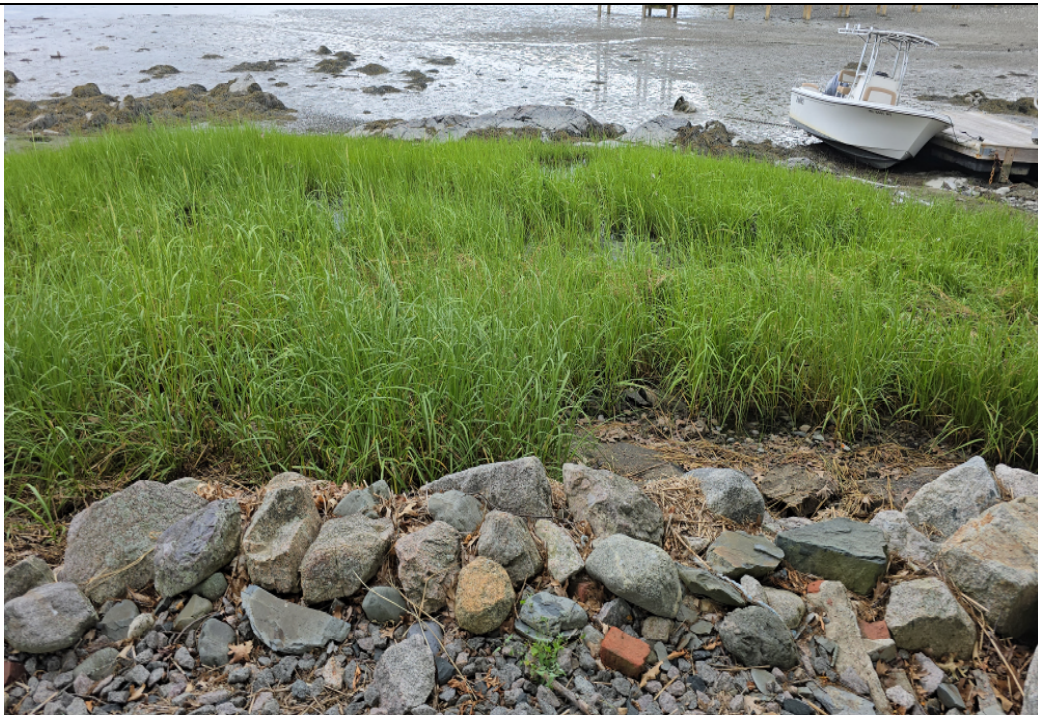
C-6

Salt marsh restoration area to the north of dock.

- Spartina alterniflora – North Side of Dock: Some of the Spartina alterniflora plantings on the north side of the dock are in good condition and have shown significant new growth. Most of the plantings, however, have not thrived due to the locations being too low in elevation.
