Appendix A: Field Forms and Sketches

HINGHAM-WALTON'S COVE

Subwatershed: Walton's Cove Outfall Pipe 1

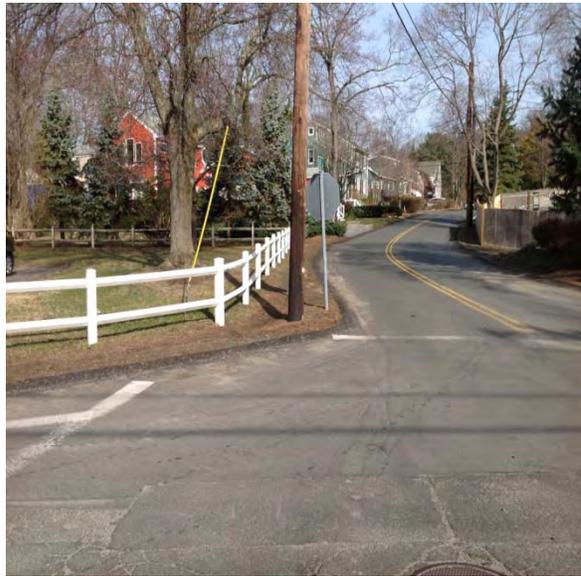
Site ID:
WCOP1-1

The Town's sewer pump station is located on the corner of Downer Avenue and Daley Road. For this site, a bioretention area is proposed in the grassy area along Daley Road to manage runoff from approximately half an acre of impervious cover. There is an existing catch basin in the road that could be modified to direct runoff from smaller storms into the bioretention, while bypassing larger flows into the existing drainage system. This site may be designed and constructed with site WCOP1-2.

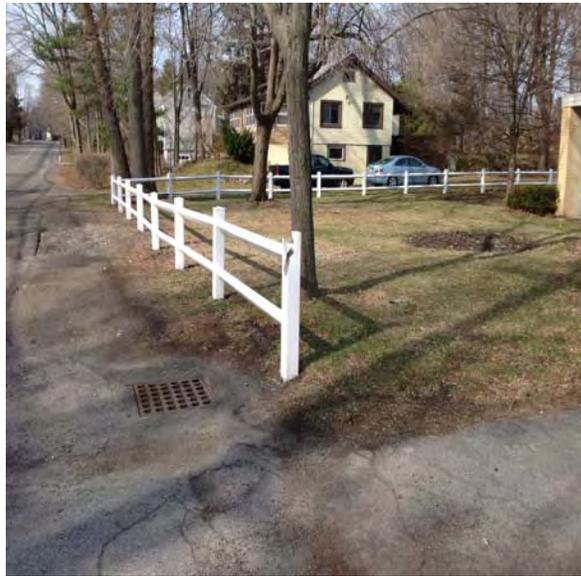
Site ID:
WCOP1-2

The Town's sewer pump station is located on the corner of Downer Avenue and Daley Road. For this site, a bioretention area is proposed in the grassy area along Downer Avenue in front of the pump station. There is an existing catch basin in the road – runoff from smaller storms from Downer Avenue would be redirected into the bioretention, while bypassing larger flows into the existing drainage system. This site may be designed and constructed with site WCOP1-1.

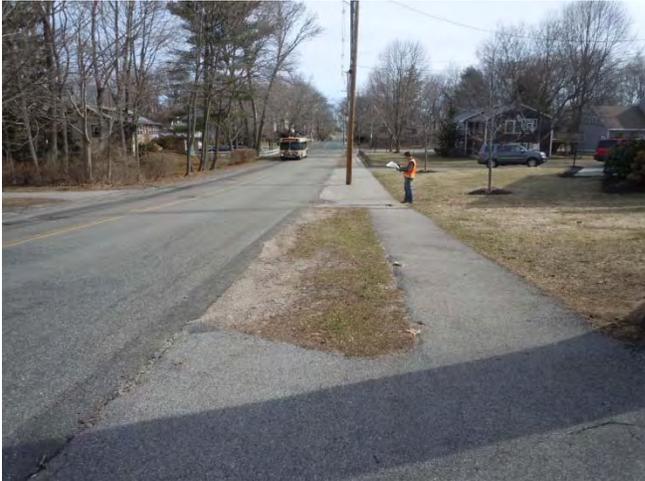
Site ID:
WCOP1-3

Site & Concept Description:
The concept for this site is to utilize the space between the sidewalk and the road for "Green streets." Green streets is a way to manage runoff in the public ROW in trenches that also support street trees. These are being used more frequently in urban locations. This is a great area for green streets given that Downer Avenue is a major road in this area, and there is already a sidewalk here. There is a stretch where it is currently paved between the sidewalk and the road – this is an opportunity for impervious cover reduction. Converting the sidewalk to a permeable surface may be considered.

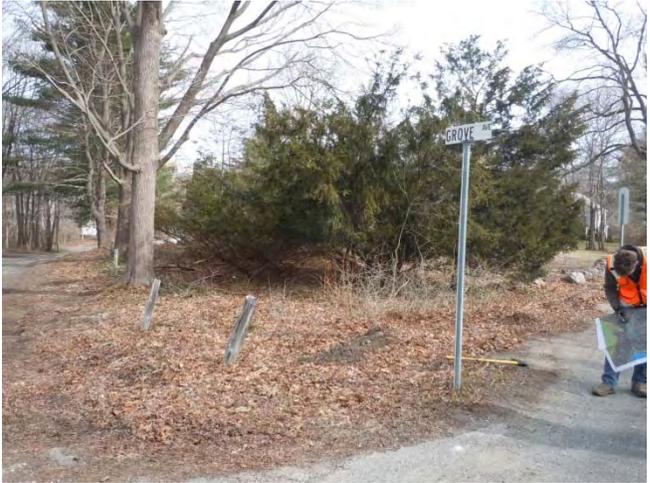
Site ID:
WCOP1-4

Site & Concept Description:
Bioretention area near intersection with Grove Avenue.

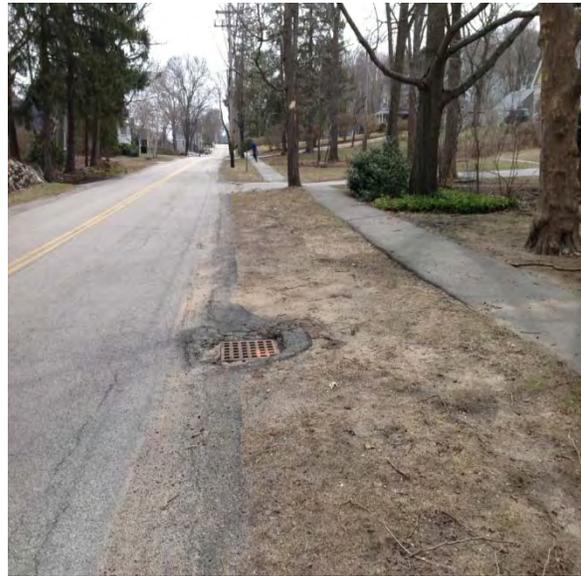
Site ID:
WCOP1-5

The concept for this site is to utilize the space between the sidewalk and the road for green streets. This is another great area for green streets given that Otis Street is also a major road in this area, and there is already a sidewalk here. Runoff from large storm events would bypass into the existing storm drain system.

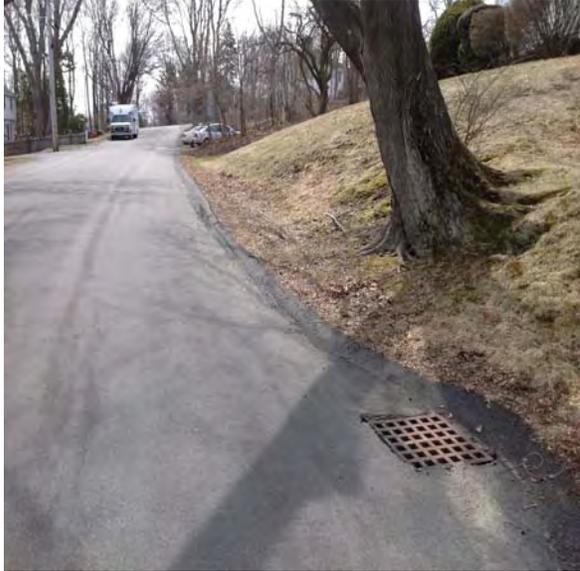
Site & Concept Description:
The concept for this site is to construct a series of dry swales along this residential street. The swales would manage runoff from smaller storm events, while larger flows would bypass into the existing storm drain system on the street.

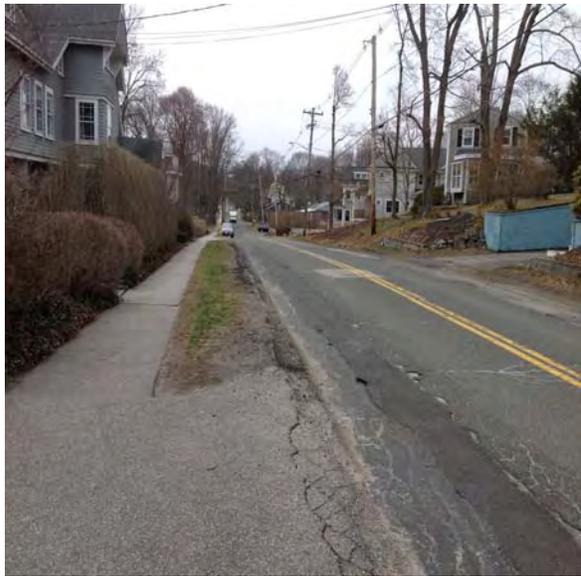
The concept for this site is to utilize the space between the sidewalk and the road for green streets. This is another location on Downer Avenue that would be great for green streets since it is a major road in this area, and there is already a sidewalk here. Runoff from large storm events would bypass into the existing storm drain system.

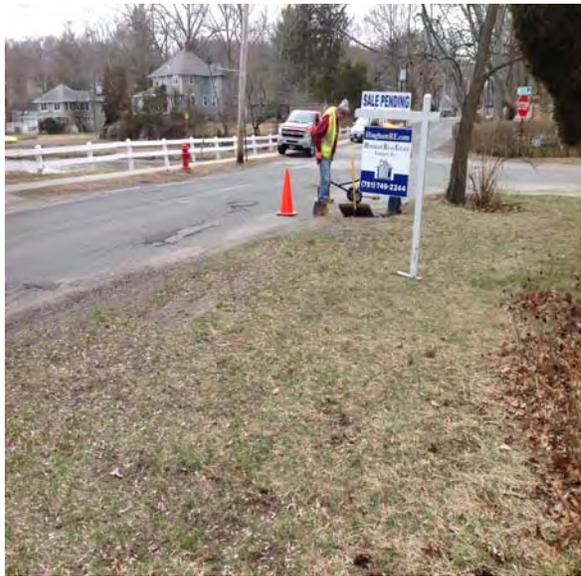
The concept for this site is to construct a bioretention area at this intersection. Runoff from larger storm events would bypass into the existing storm drain system.

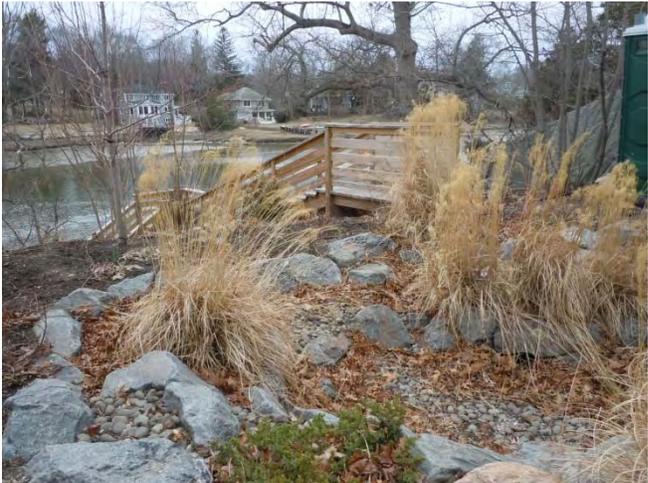
There is an existing stormwater basin at the end of this private road that discharges near the mouth of Walton's Cove below a set of stairs. This basin's overflow pipe is located at the bottom of the basin; thus, not providing much detention of stormwater for settling of sediments. This can be easily modified by retrofitting the outlet.

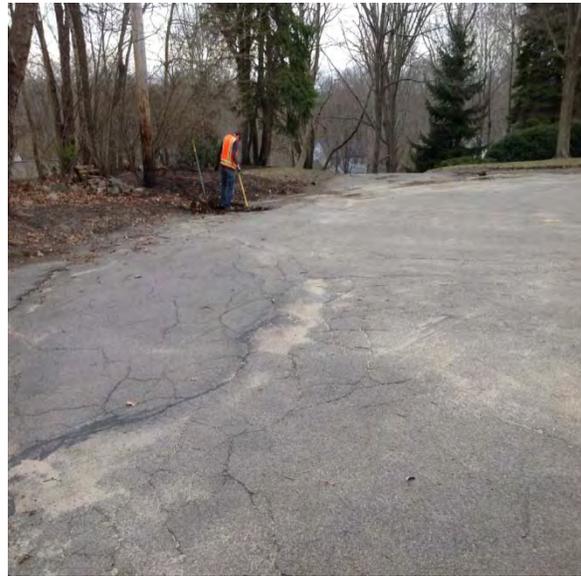
Appears that there are existing drainage issues here from ponding/clogging at the existing catch basin. The concept for this site is to remove excess pavement from an oversized cul-de-sac and use bioretention areas/swales to manage runoff.

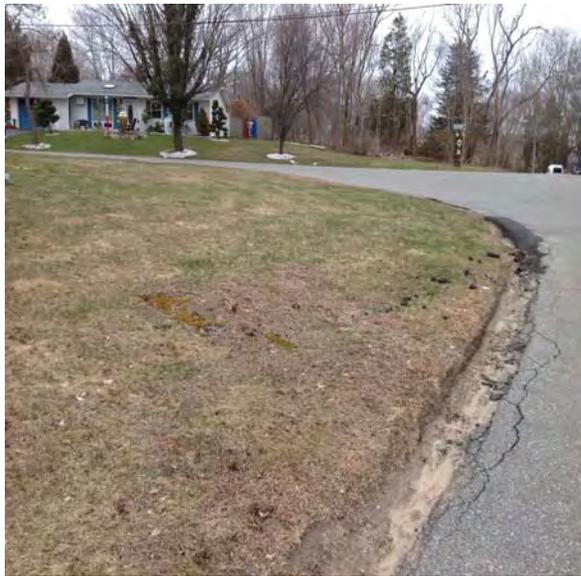
There is a large open grassy area at this oversized intersection. Currently, stormwater flows along the edge of the road, eroding the soil and undermining the pavement. The concept is to remove excess pavement at intersection and use a bioretention area to manage runoff. Overflows from large storm events would continue to flow down Ocean View.

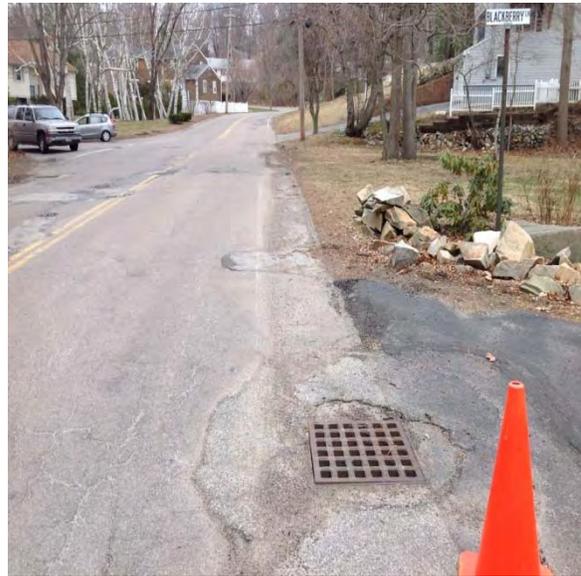
The runoff from this road discharges to the Fee Pond wetland complex. The concept is to construct a dry swale in the ROW to manage runoff.

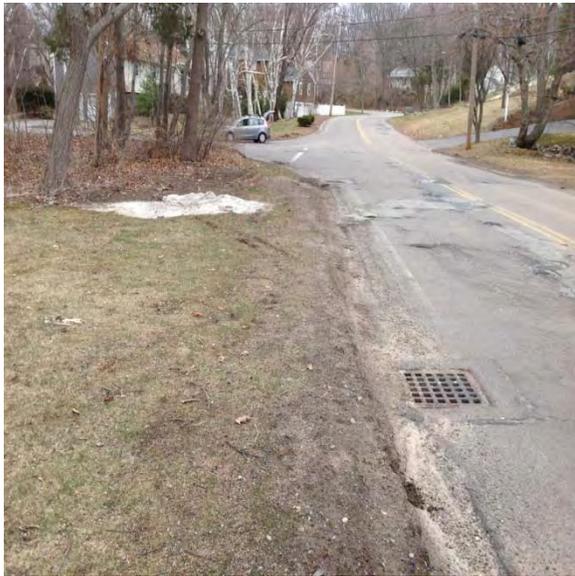
The runoff from this road discharges to the Fee Pond wetland complex. The concept is to construct a dry swale in the ROW to manage runoff. Some impervious cover reduction can be achieved at the intersection with Ocean View.

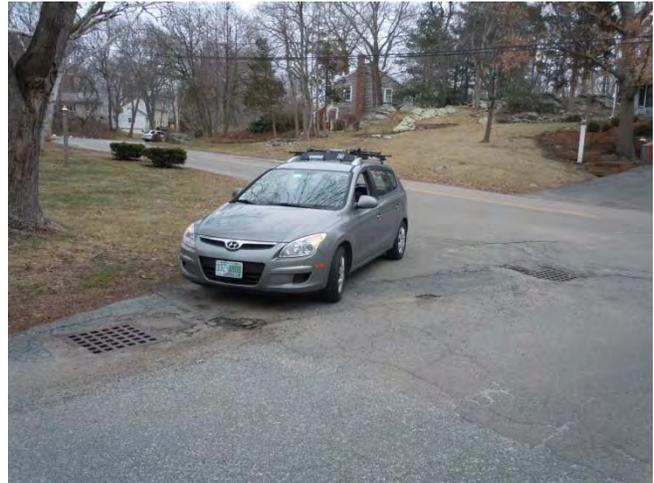
Site ID:
FP-5

Name: Park Circle at Ocean View - Bioretention

Site & Concept Description:

This intersection appears to be oversized. Pavement can be removed, and a bioretention area can be constructed within the ROW.

Existing site catchbasins can be utilized for basin overflow and bypass.

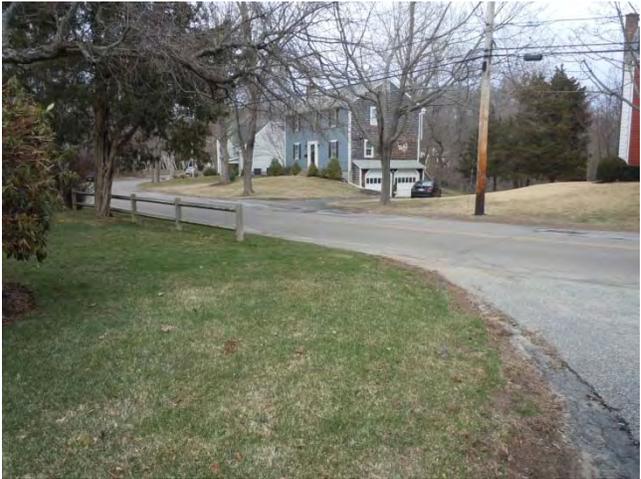
Name: Park Circle at Cul-de-Sac N - Bioretention

Site & Concept Description:
This cul-de-sac is oversized. Water service and sewer manholes are location in the driving lanes. The concept for this site is to remove excess pavement, creating a larger planted island and creating an easier access to utilities, while treating runoff with a bioretention area near the northern edge of the intersection with Park Circle. Should be designed with Site FP-7.

Additional Notes/Feasibility:
Need to confirm limits of ROW.

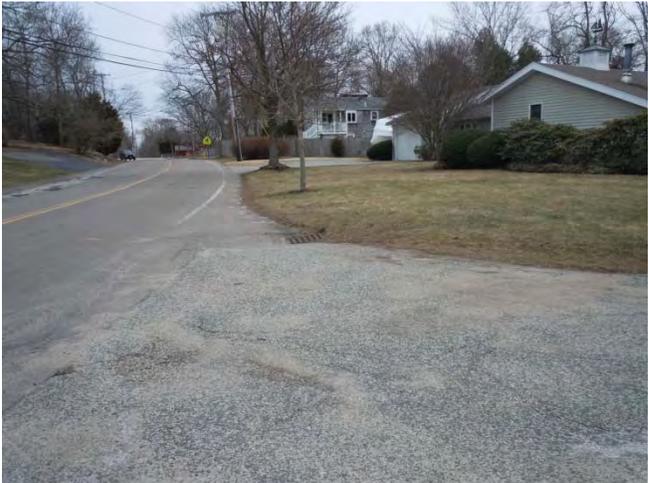
Site & Concept Description:
This cul-de-sac is oversized. Water service and sewer manholes are location in the driving lanes. The concept for this site is to remove excess pavement, creating a larger planted island and creating an easier access to utilities, while treating runoff with a bioretention area near the southern edge of the intersection with Park Circle. Should be designed with Site FP-6.

Additional Notes/Feasibility:
Need to confirm limits of ROW.

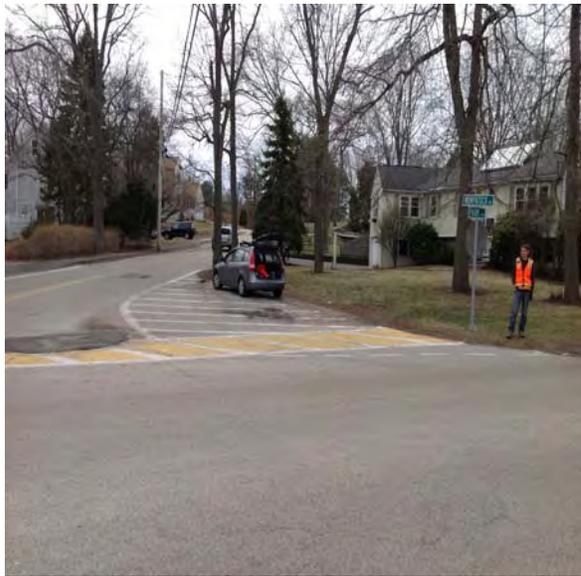
Name: Planter's Field Ln at Wompatuck Rd - Bioretention

Site & Concept Description:
There are several areas at this intersection with striped, unused pavement. The concept is to remove this pavement and use the area for bioretentions. This should also help to calm traffic at this major intersection.

Additional Notes/Feasibility:
Need to confirm that the pavement in these areas can be removed. May require realignment of the existing cross-walk.

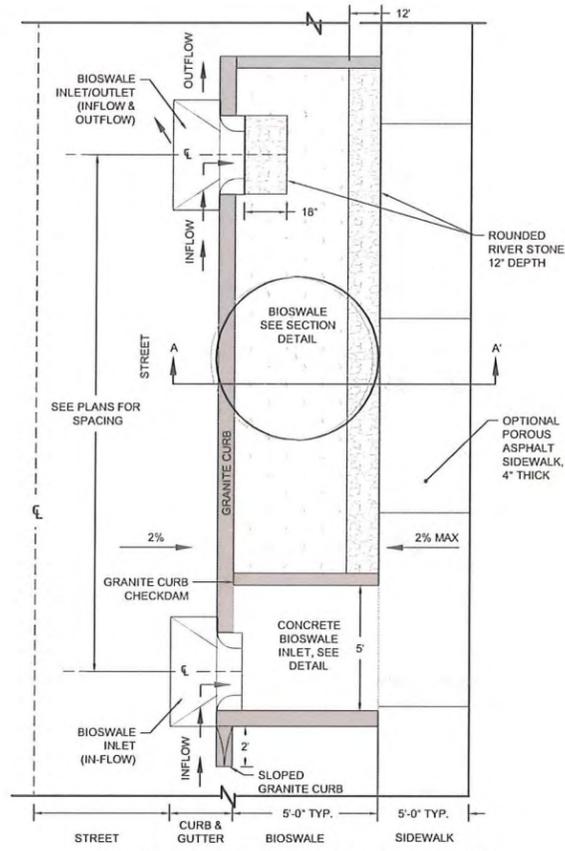
BIOSWALE / TREE TRENCH TYPICAL PLAN VIEW
NOT TO SCALE

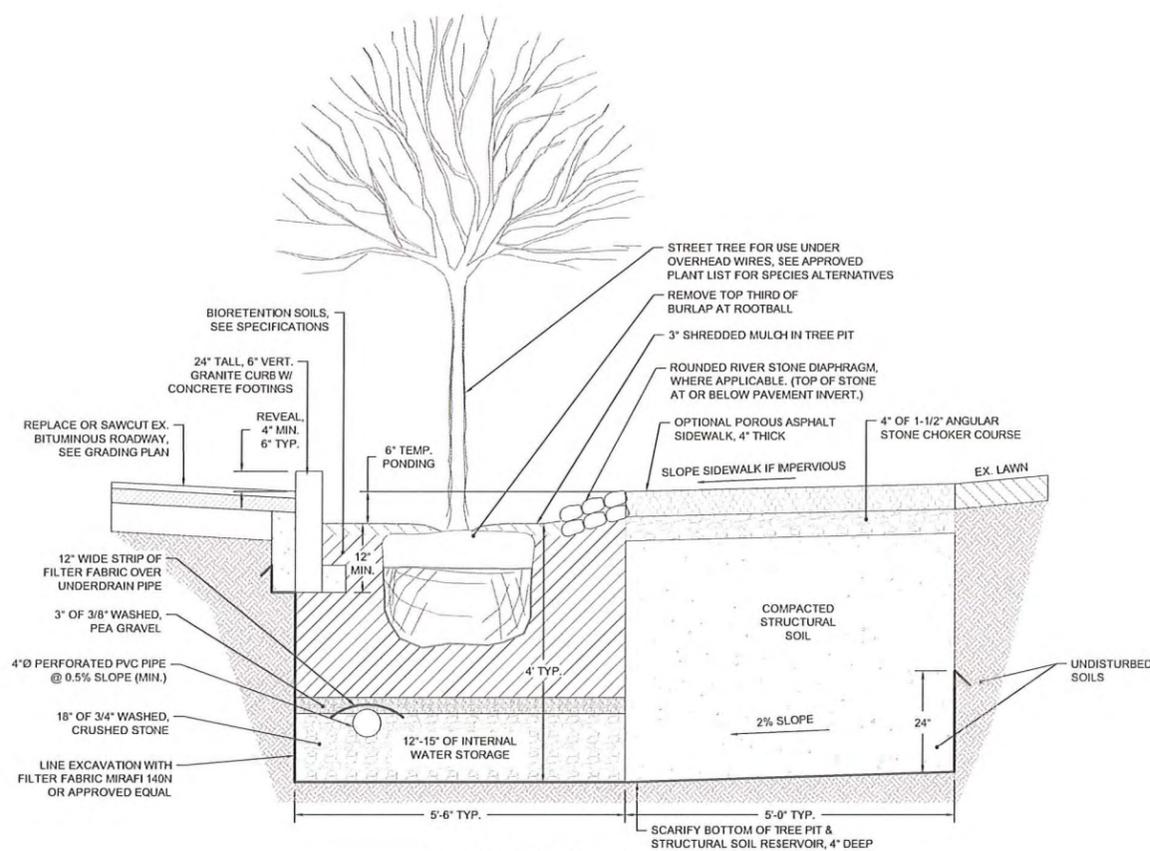
BIOSWALE / TREE TRENCH TYPICAL SECTION A-A'
NOT TO SCALE

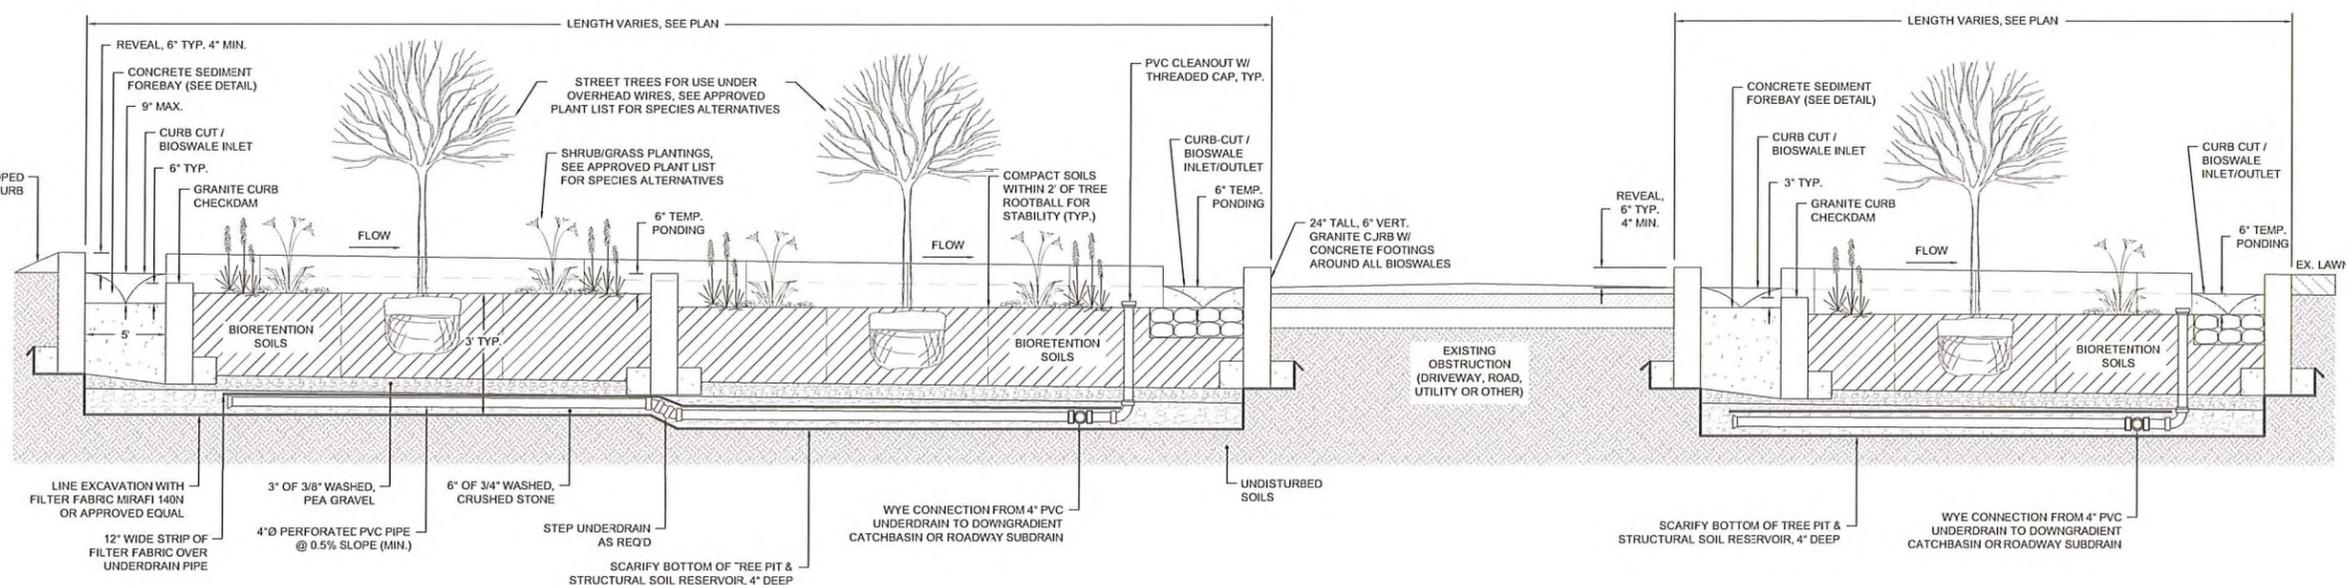
BIOSWALE / TREE TRENCH TYPICAL SECTION B-B'
NOT TO SCALE

- NOTES:**
1. LONGITUDINAL SLOPE OF PLANTER MATCHES ROAD. FLAT AS POSSIBLE, 3% MAXIMUM.
 2. LONGITUDINAL AND CROSS SLOPE OF SOIL WITHIN PLANTER: NONE, FLAT AS POSSIBLE.
 3. SEE BIORETENTION/BIOSWALE SOIL SPECIFICATIONS AND PLANTING REQUIREMENTS.
 4. INSTALL WASHED, RIVER ROCK TO TRANSITION FROM SPLASH PAD TO SOIL.
