RE: **Request to Amend Special Permit A2**
Site Plan Review in Association with Special Permit A2
208 Downer Avenue - Hingham, MA 02043

The purpose of this letter is to accompany revised materials associated with a Request for Site Plan Review in Association with a Special Permit A2; and to Amend an existing Special Permit A2 to remove an existing storage barn and construct a new two-story boat storage barn at 208 Downer Avenue.

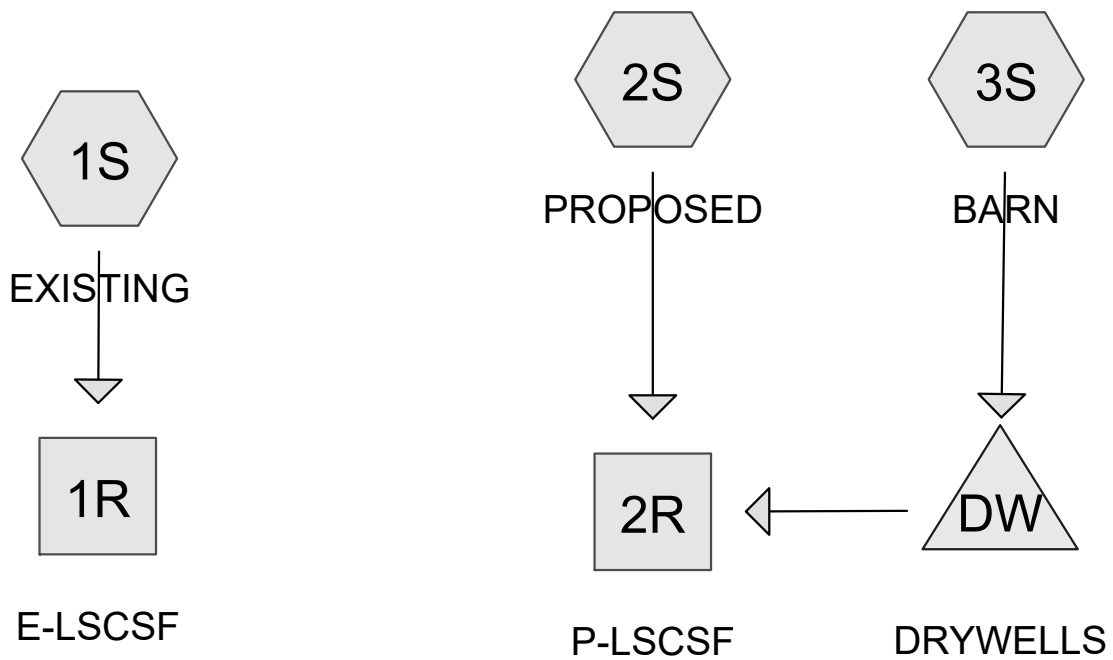
Time span=0.00-48.00 hrs, dt=0.01 hrs, 4801 points
Runoff by SCS TR-20 method, UH=SCS, Weighted-CN
Reach routing by Stor-Ind+Trans method - Pond routing by Stor-Ind method

Subcatchment 1S: EXISTING Runoff Area=21,220 sf 2.62% Impervious Runoff Depth=2.26"
Tc=5.0 min CN=91 Runoff=1.31 cfs 0.09 af
